Taylor Fork of the Gallatin River 4B Water Quality Analysis Gallatin National Forest

October 25, 2007

4B Water Quality Analysis

Gallatin National Forest¹

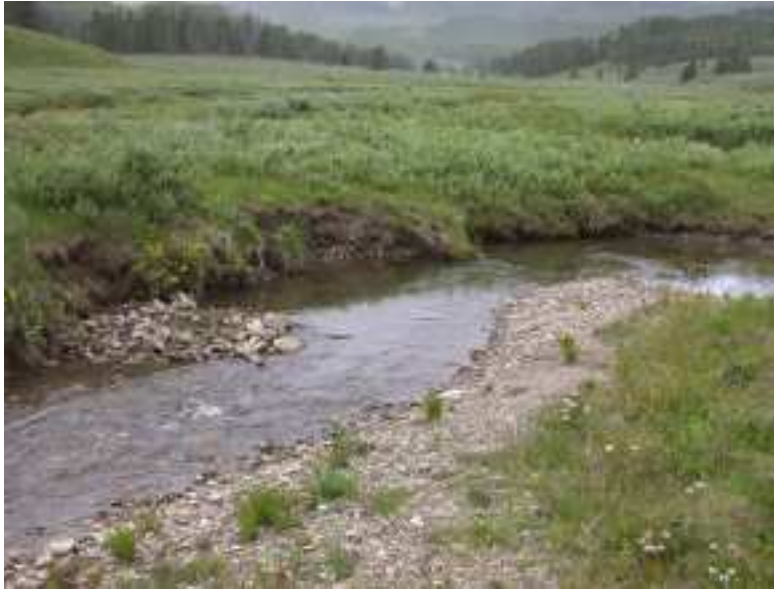
Photo 1. Impacted riverine wetland in the Cache-Eldridge Allotment, with streambank trampling and a relatively wide shallow channel. Fish numbers are 26/100 square meters within this reach and the % of fine sediment <2mm is 21%, which represents a fair condition. This rating is based on based on a combination of values found in scientific literature (Reiser and Bjornn, 1979) and professional judgement.

The Cache-Eldridge Allotment was approved in 2006 (USFS- Gallatin NF, 2006b) which eliminate the Cache Pasture and excluded livestock grazing from Cache Creek. The changes proposed under all of the alternatives are designed to improve stream conditions and are a normal component of BMP upgrades. Some of these sections in 2003, particularly the East Fork of Cache Creek and the South Fork of the East Fork had destabilized streambanks from livestock grazing and bank trampling that acted as sediment sources during high streamflow periods. These sections were not been grazed by livestock in 2004 and 2005 and were be closed to livestock grazing in the Cache-Eldridge AMP revision in 2006.

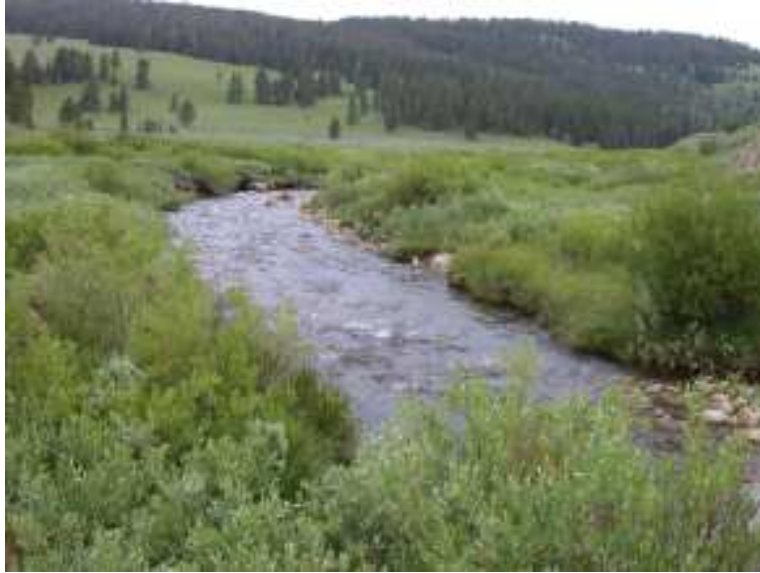
Photo 2. Little Wapiti Creek, Wapiti Allotment. Note the healthy riparian vegetation and stable banks. This stream is a Rosgen (1996) C3b channel type with a good channel stability rating and in proper functioning condition. (August, 04).

The Wapiti Grazing Allotment revision National Environmental Policy Act (NEPA) planning will be completed in fiscal year 2008. An initial evaluation of riparian-grazing interactions found very limited grazing impacts and relatively stable stream channel conditions (see photo 2). A section of Little Wapiti Creek near the allotment boundary in Section 25 has concentrated grazing in about ½ square mile area adjacent to the allotment boundary which will be addressed in the Wapiti allotment management plan (AMP) revision. This segment is shown on the Taylor Fork watershed and project map (Figure 1). The following photo shows a proper functioning healthy stream reach in the Little Wapiti Pasture of the Wapiti Grazing Allotment.

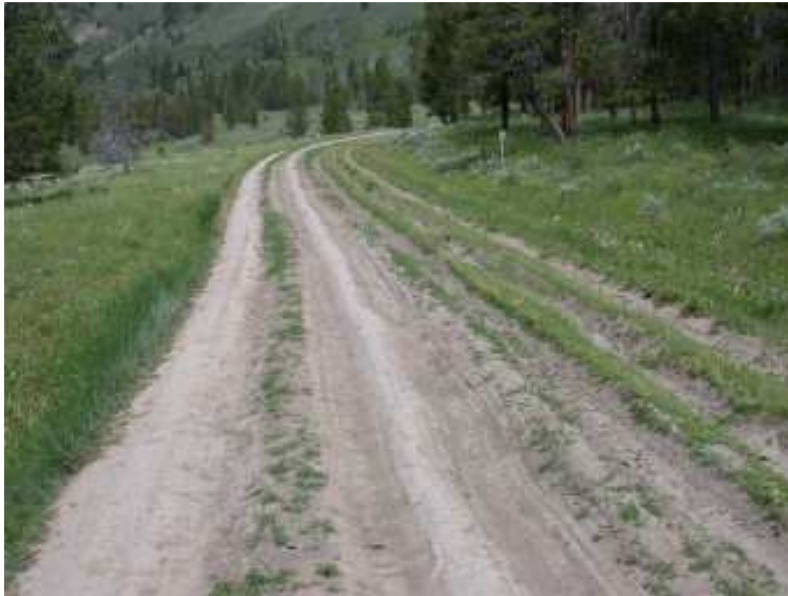
Photo 3. Cache Creek Road Identified for Gravel Surfacing in 2006.

The most significant road related sources of sediment are the un-surfaced roads in the upper ends of the Taylor Fork and the Cache Creek watersheds. The Cretaceous sediment geology found in this area is not well suited for un-surfaced, native material roads, because it is easily eroded.

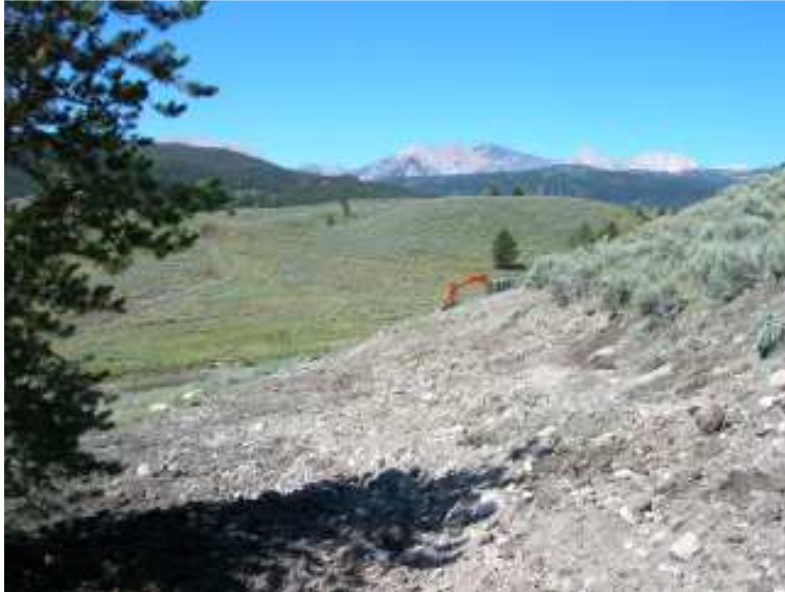
Photo 4 . Re-contoured road in T9S R3E S1. Treatment consisted of pulling fill slopes and packing back in the road prism to cover the cut slopes. Topsoil was placed on the surface as much as possible. The re-contoured road prisms were then seeded and hydro-mulched. The upper left part of the picture is a road segment to a former cabin which was ripped, drained, and seeded (Photo taken on 7/27/05).

National Forest. Access roads to the Section 1 cabins were decommissioned (re-contoured and hydro-mulched or ripped, drained, and seeded) in July/August of 2005.

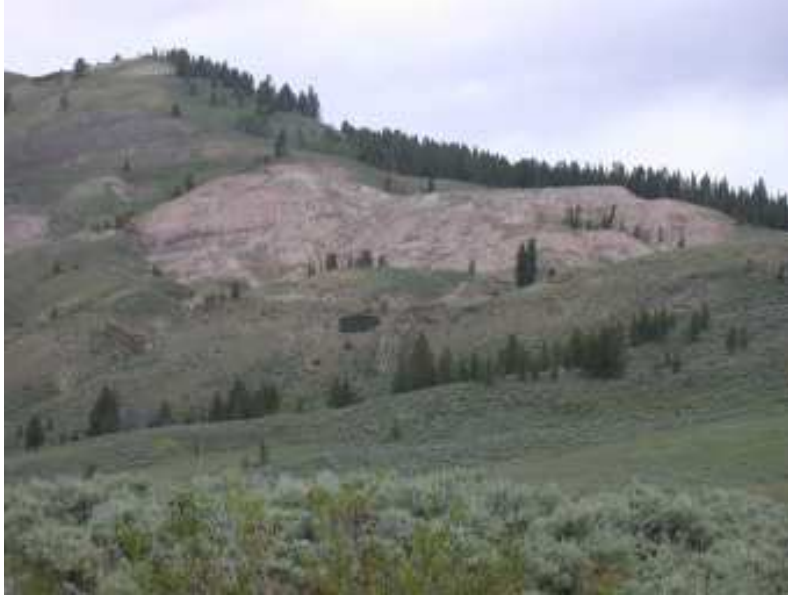
Photo 5. Lower Taylor Fork Cretaceous sediments.

Cretaceous sediments found extensively in the Taylor Fork watershed are the primary source of sediment in the drainage. The western two-thirds of the Taylor Fork watershed and virtually the entire Cache Creek drainage have Cretaceous sediment parent material. During snowmelt runoff and particularly from high intensity rain events the Cretaceous sediments, which are high in clay content, can turn Taylor Fork and even the entire Gallatin River turbid for a few hours. The highest concentration of Cretaceous sediments occurs in Cement Creek where over 300 acres of “badlands” are present. These have little vegetative cover and are comprised of Meade Peak (Albino) Shale. This area erodes easily and yields large amounts of fine sediments as a result of active rill and gully cutting. Salts, iron, phosphate, and selenium are found in these fine sediments. While these contributions may adversely impact aquatic biota, they are naturally occurring, so no treatments are planned to reduce sediment yield from this area.

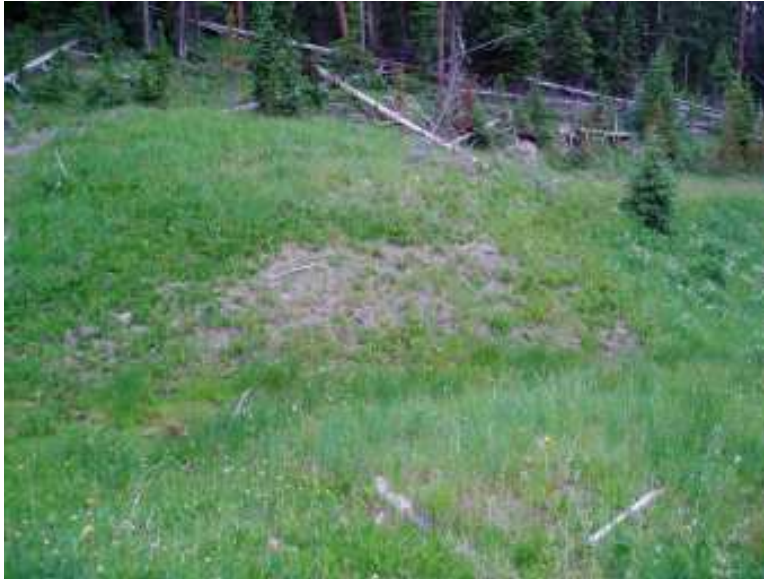
Photo 6. The East Fork of Cache Creek Road was decommissioned in 2002. The culverts were removed, slopes laid back, and the area seeded. The site is completely recovered and the road tread does not have any rill erosion evident.

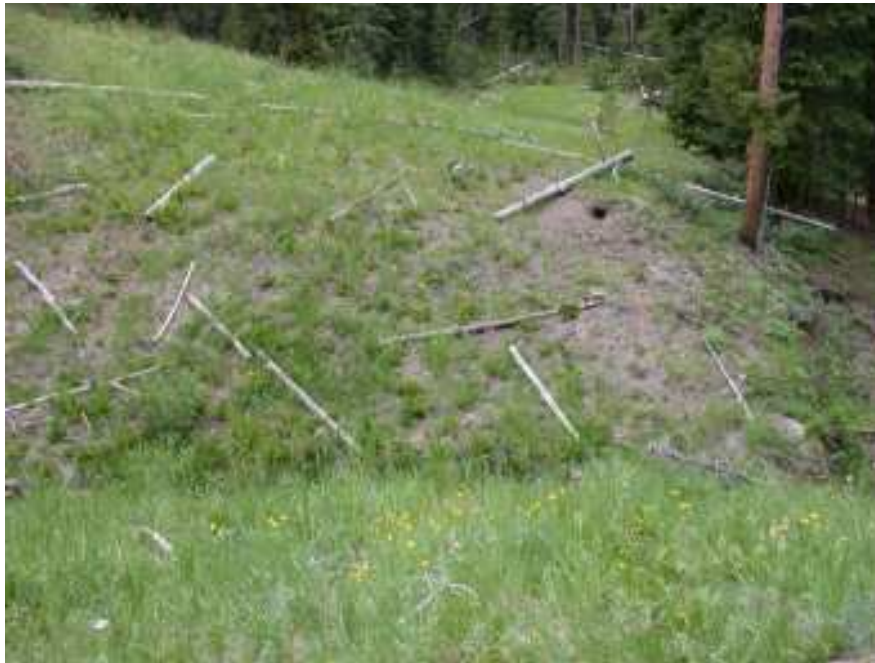
Photo 7. East Fork FK Cache Ck Road. The road surface was ripped, seeded, and drained. Logs were placed on cutbank slope to catch sediment and stabilize the slope.

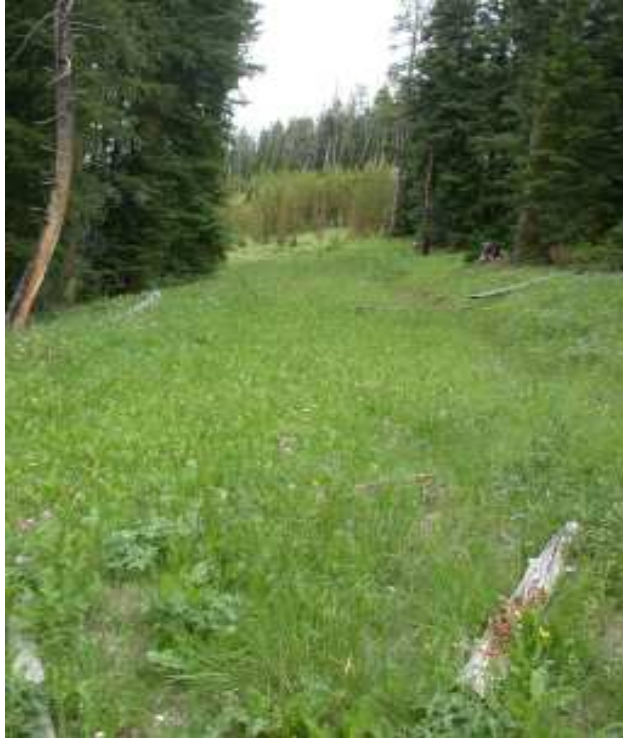
Photo 8. East Fork Cache Creek Cache Ck Road. Seeded and Stabilized Road. This road section is typical of most of the decommissioned road segments in Cache Creek. Note lodgepole regeneration in historical timber harvest unit in the distance. Both the road and timber harvest unit in this area are no longer sediment sources to Cache Creek.

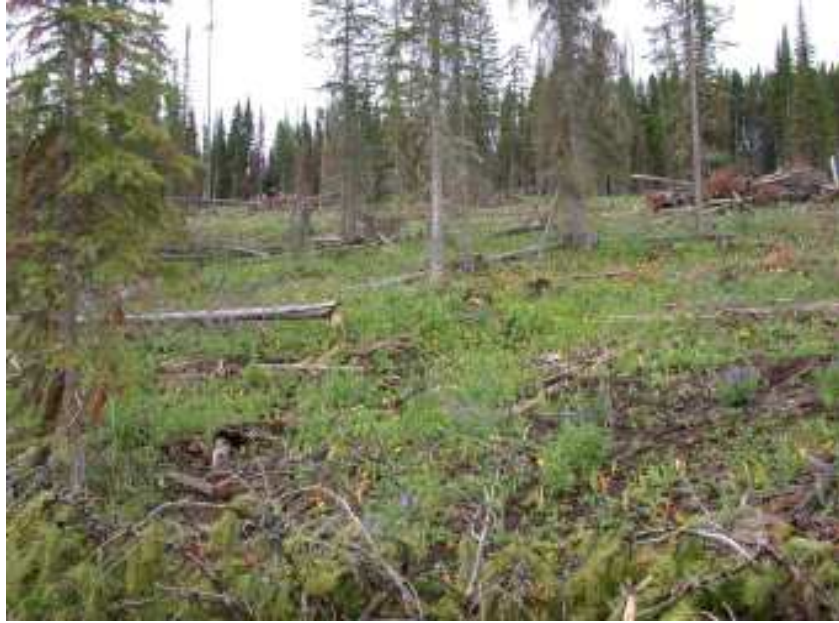
Photo 9. Taylor Helio Unit # 113 (2004) two years post harvest.

Timber harvest in the Taylor Helio Sale is completed, and provides good evidence of the effectiveness of the BMPs implemented. All of the tractor units are completed and the work accepted by the Timber Sale Administrator. Helicopter units were completed in December 2004. All sale closure activities (site preparation, grapple pile cleanup, and landing pile burn and top soiling) were completed by 8/05 when the sale contract terminated. Photo 9 was taken in Unit 113 which was harvested in the fall of 2002. The unit has been closed and accepted. There is no evidence of overland movement of sediment.

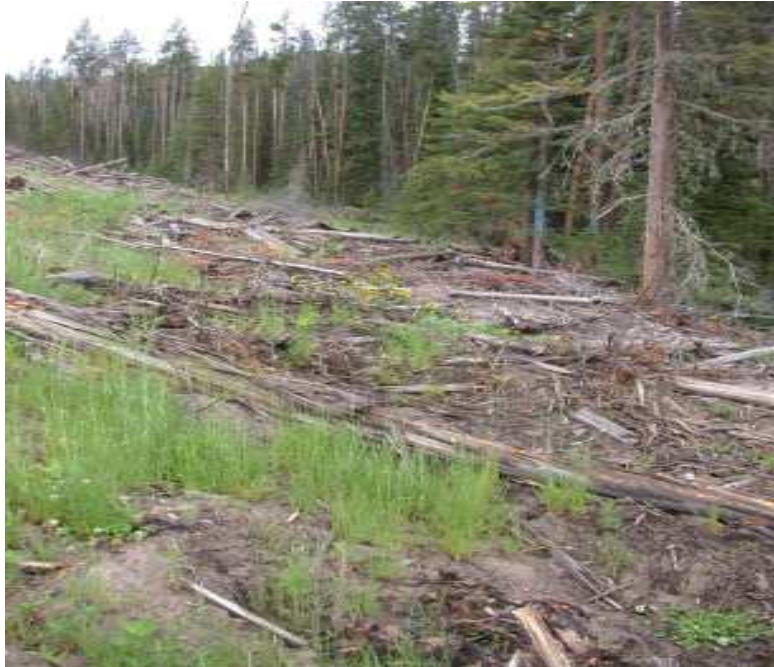
Photo 10. Slashed Skid Trail in Taylor Helio Sale. The skid trail was ripped, seeded, then slashed. The treatment is designed to eliminate erosion potential and protect soils.

The skid trail in Photo 10 was slashed after the unit was completed. Skid trail rehabilitation was implemented throughout the Taylor Helio Sale with similar results of no soil displacement.

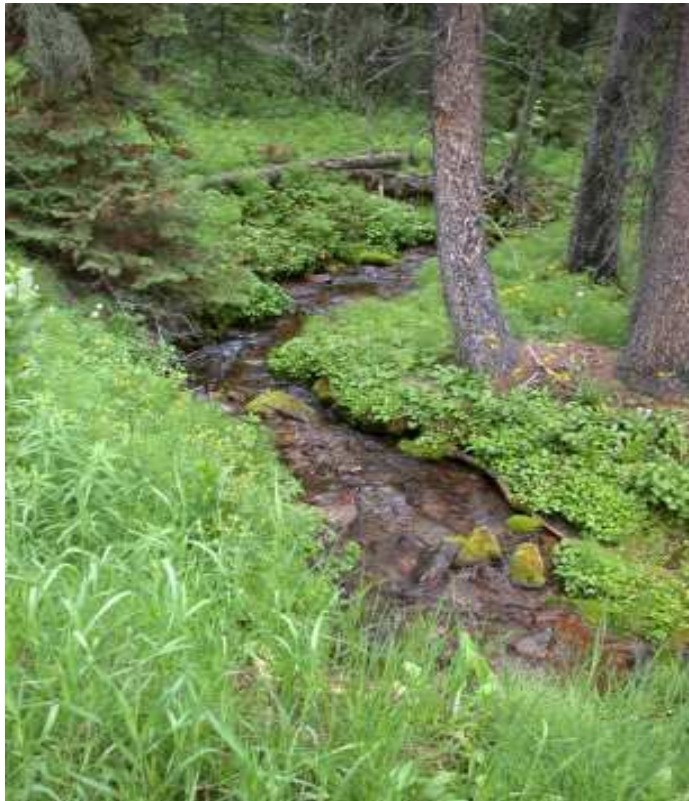
Photo 10. North Fork of Deadhorse Creek 50 feet below Unit 113 of the Taylor Fork Helio Sale. There is no evidence of sediment entering the channel, indicating that the BMPs were effective.

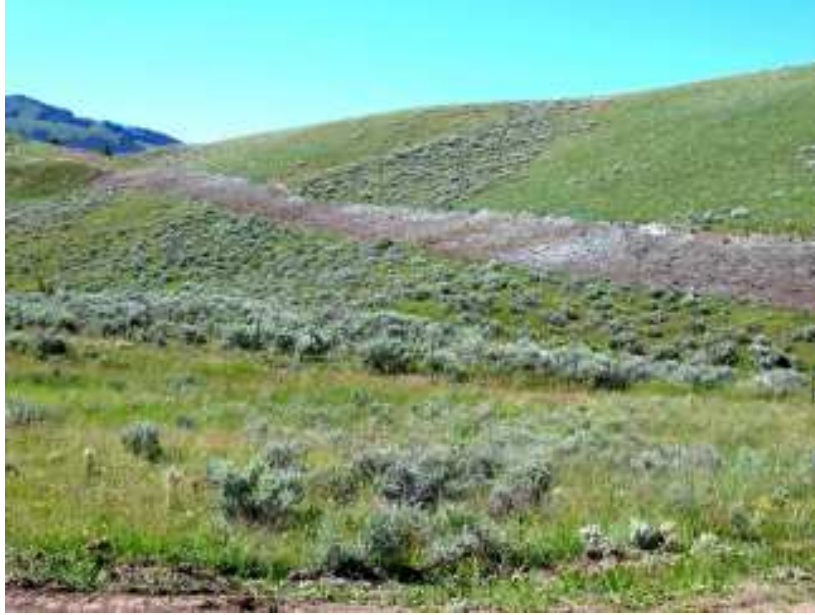
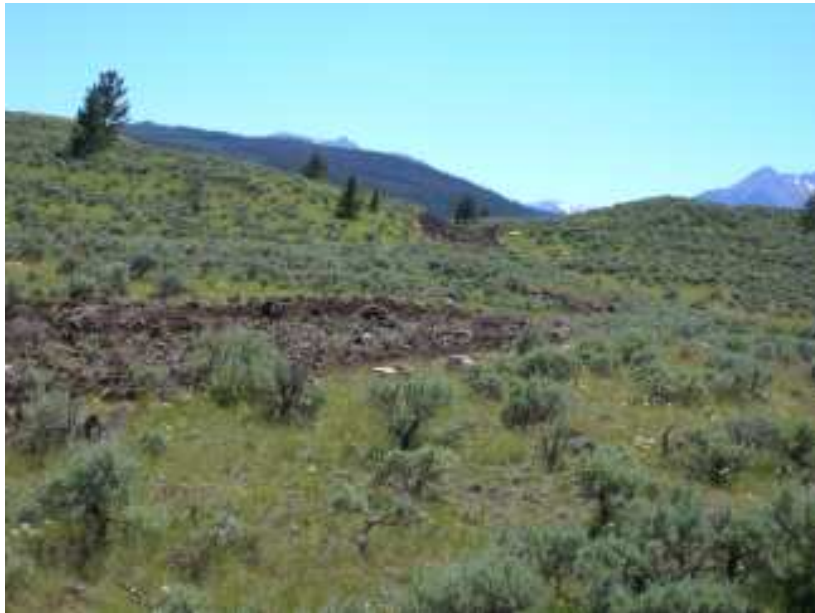
Photos 11 and 12 Decommissioned Roads - Both of these photos were taken in 8/05 in T9S R3E S1 in the rehabilitation of lands acquired by the Gallatin NF. The upper photo is a re-contoured road section after hydro-mulching. The lower photo is a ripped, drained, and seeded road segment to a former cabin site (removed in 9/04). Re-contouring was done with a small excavator for road segments with large cut and fill slopes. The rip, drain, and seed treatment was used on road segments with small enough of cut and fill slopes to be restored with a dozer.

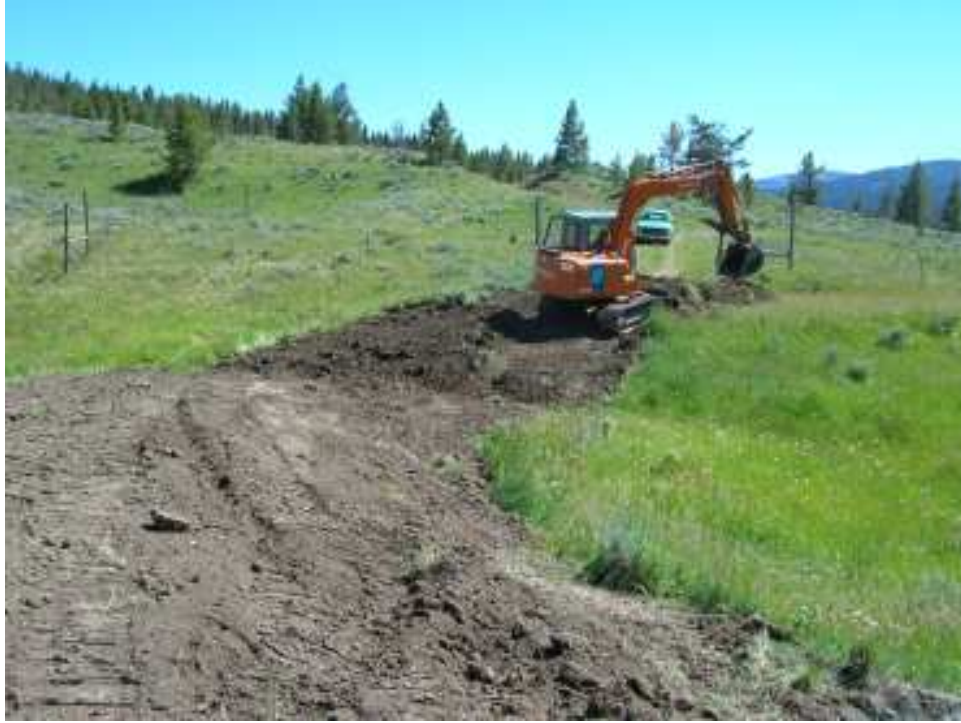
Photo 13. Decommissioning - This photo in T9S R3E S1 was taken on 7/27/05. A culvert was removed and stream banks restored to pre-road channel geometry. The area was then seeded and hydro mulched. Revegetation response is expected to be robust. The treatment is designed to eliminate the road as sediment source and avoid a long term potential sediment source if the culvert fails. The road decommissioning work on Gallatin NF lands during 2002-2005 has removed 55 culverts in the Taylor Fork watershed.
